Reformulation of the CBR Procedure

Report II: Design, Construction, and Behavior Under Traffic of the Pavement Test Sections

Carlos R. Gonzalez, Walter R. Barker,
and Alessandra Bianchini

December 2013

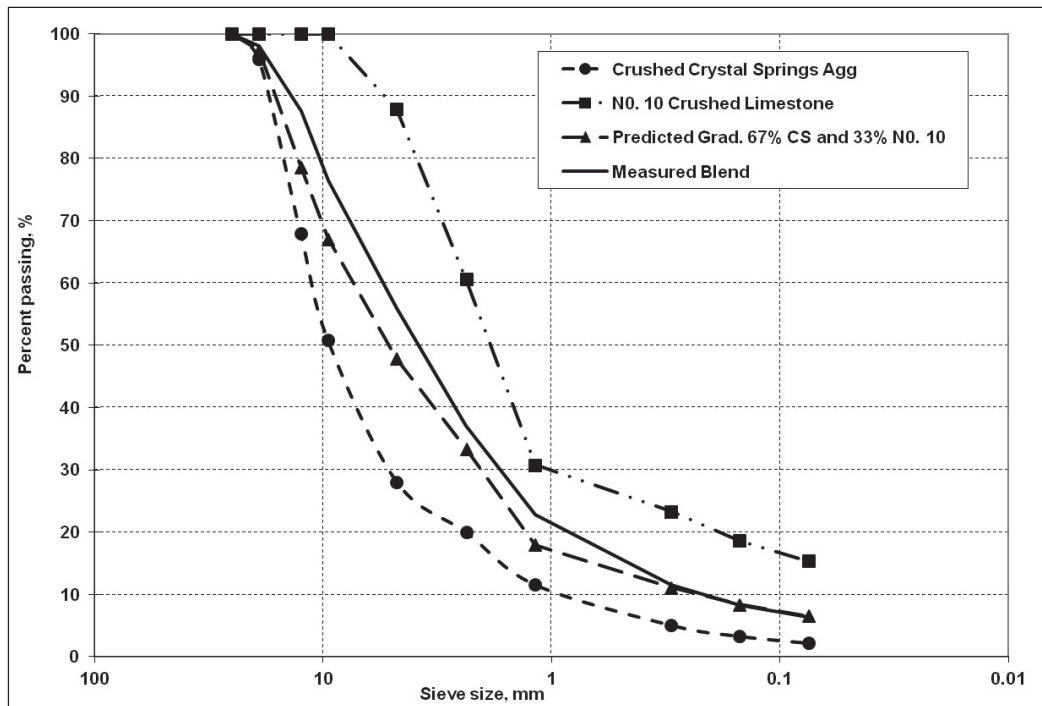
Figure 12. Subbase aggregate blend grain-size distributions.

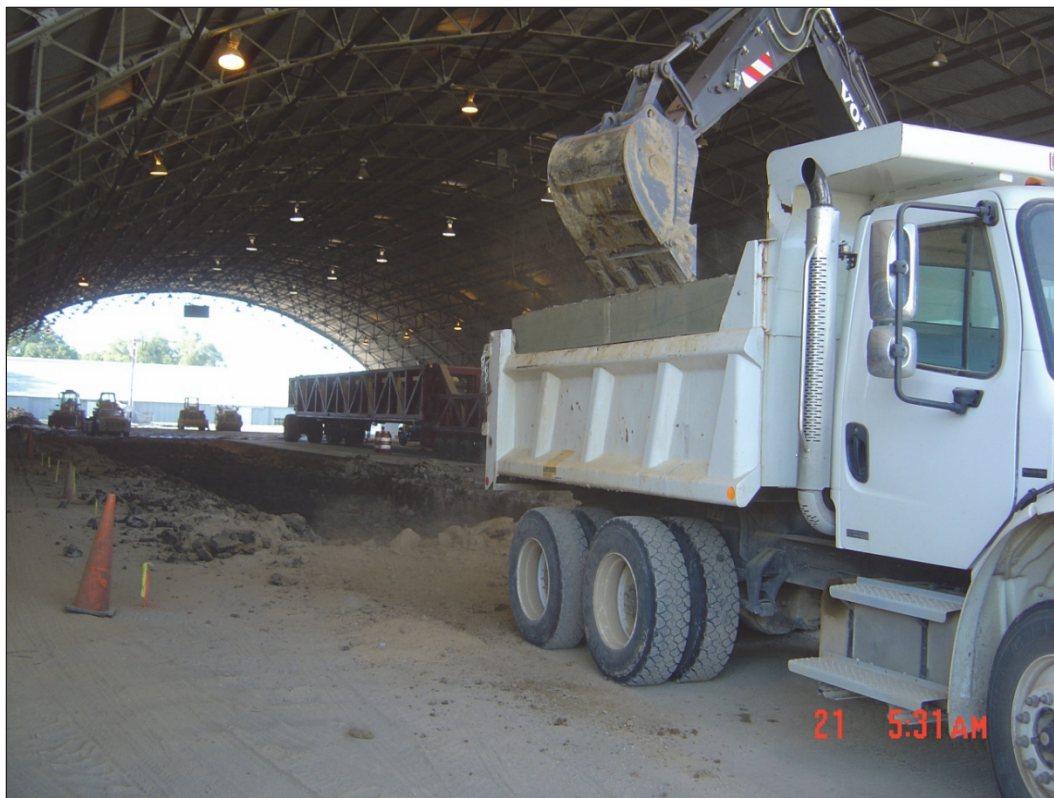
Figure 18. Test section excavation.

The CH material was placed and compacted in four lifts for the subgrade of Item 1. After placement of the CH material for Item 1, the CL fill was graded to the proper depth to allow placement of the CH subgrade for Item 2. The CH material was again placed and compacted in four lifts over a plastic moisture barrier. For Items 3 and 4, the CL layer was graded to the proper elevation to allow the placement of the CH material layer. A lift of CH material was first placed in Item 4, followed by subsequent lifts for both Items 3 and 4, which were placed at the same time to obtain a total layer thickness of 2 ft of CH material. Figure 17 shows a schematic final profile of the CL and CH layers that were constructed for this test section. Figure 18 shows the test section excavation.

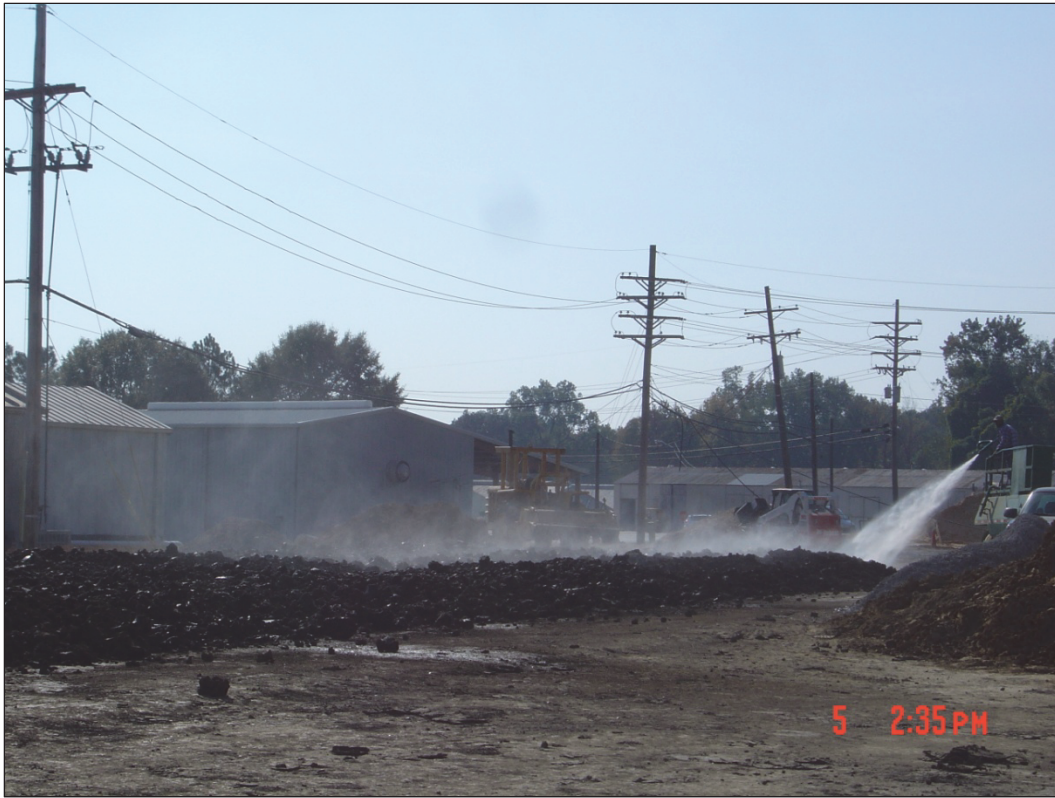
Figure 19. Adding water to the subgrade material.

The subgrade material was processed at a facility next to Hangar 4 before its placement. Material processing consisted of spreading the clay in a uniform strip to a depth of approximately 12 in. and tilling the soil with a rotary mixer to break all material clumps and ensure uniformity. The subgrade design CBR for each test item was achieved by adding water or drying the CH material to the appropriate moisture content predicted from Figure 9. Figures 19 and 20 show the material processing.

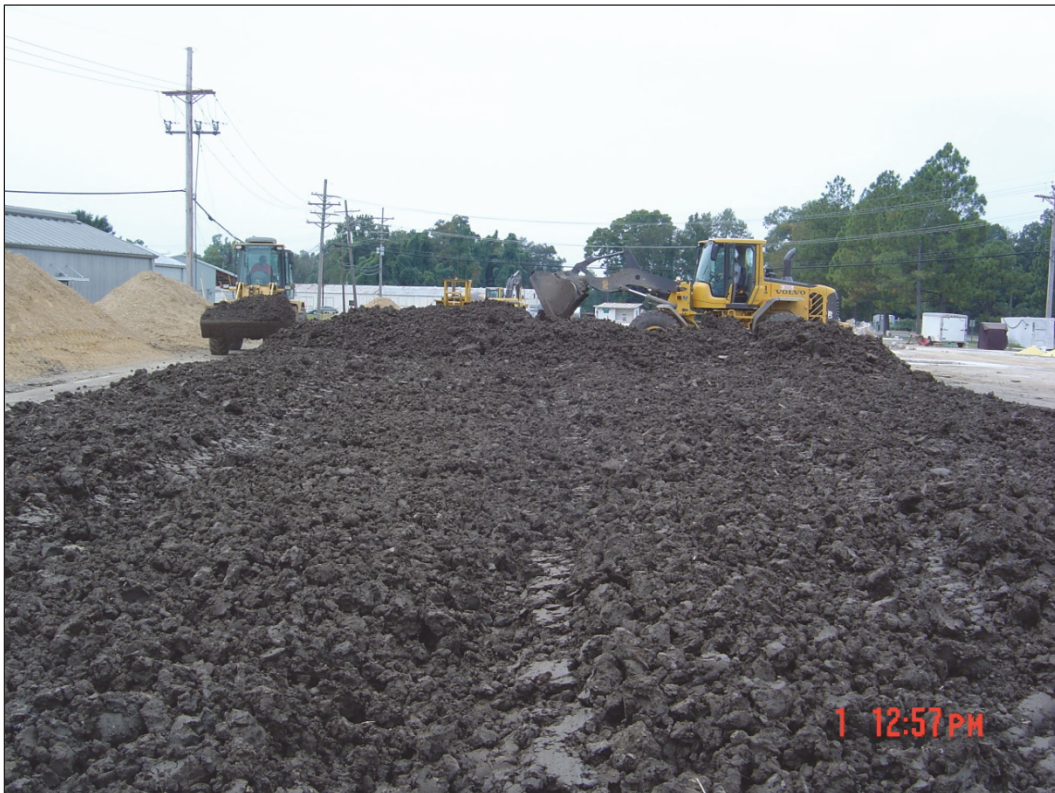
Figure 20. Subgrade material processing.

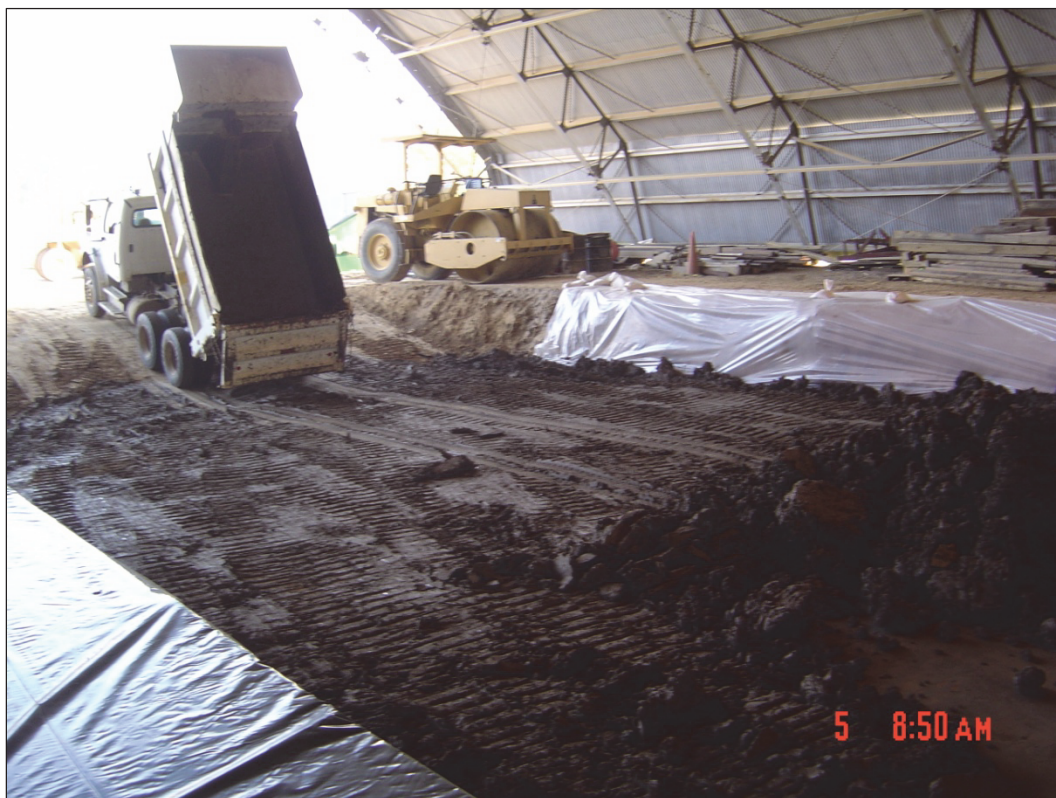
Figure 21. Subgrade material placement.

When the strength and moisture content of the material were not sufficiently close to the target values, the material was processed to adjust the moisture content by either adding water or allowing the material to air dry. After obtaining the correct strength (in terms of CBR) of the lift, the lift surface was scarified by lightly tilling prior to placing the next lift; this process was repeated for each subsequent lift. During the construction process, the material was not allowed to lose moisture. During breaks in the construction process, the surface of the compacted layer was lightly sprinkled with water and covered with plastic sheeting. Each test item was overbuilt a few inches to allow for the final grading of the subgrade surface prior to placement of the subbase material. After the subgrade final grading, the subgrade was sampled with a 10-in.-diam Shelby tube, and earth pressure cells (EPCs) were installed. Installation of EPCs and instrumentation will be discussed in Chapter 4. Figures 21 and 22 show subgrade placement activities.

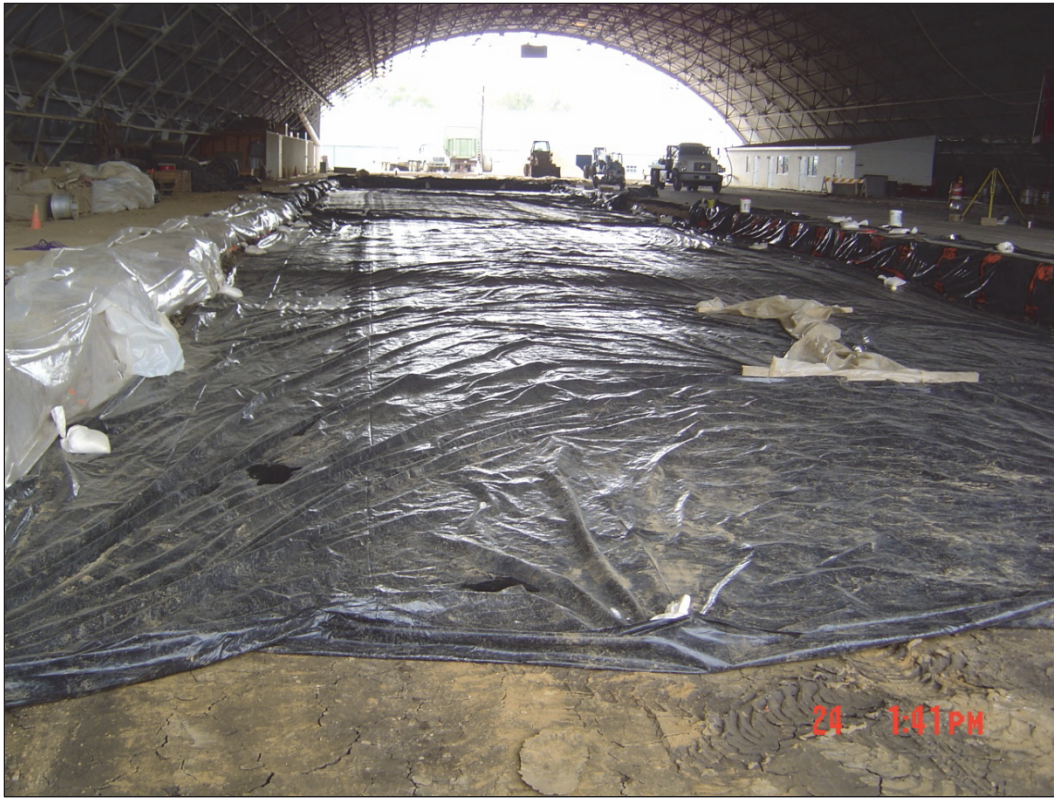
Figure 22. Subgrade layer covered after compaction.

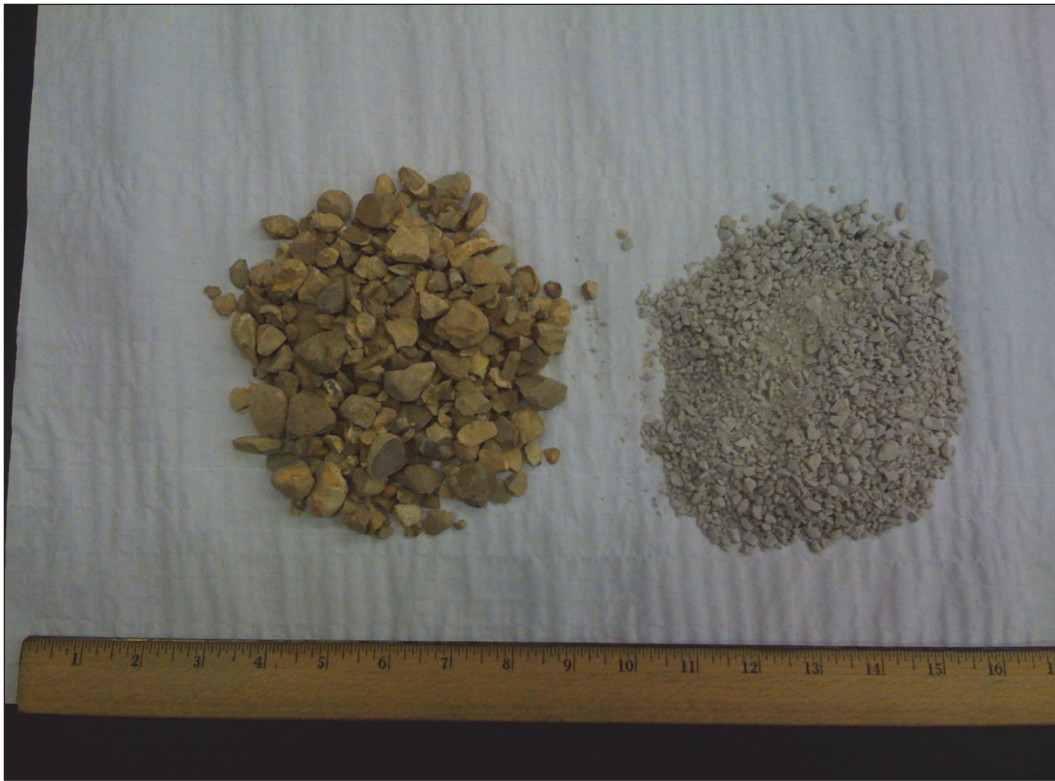
Figure 23. Material included in the subbase blended mix: crushed aggregate (left) and crushed limestone (right).

The subbase material, a blended mix of 67% crushed aggregate (Figure 23, left) and 33% No. 10 crushed limestone (Figure 23, right), was placed in lifts to total thicknesses of 7 to 23 in. to achieve the required design thicknesses. The subbase material was delivered by dump trucks and placed in 5- to 7-in.-thick lifts. Each lift was compacted by 22 passes of a vibratory steel-wheel roller. Target moisture content to achieve 100% modified Proctor compaction was 3.5%. During compaction, the subbase material was kept moist by sprinkling each lift with water prior to each pass of the vibratory roller. Figures 24 and 25 show stockpiled subbase material and subbase construction activities, respectively.

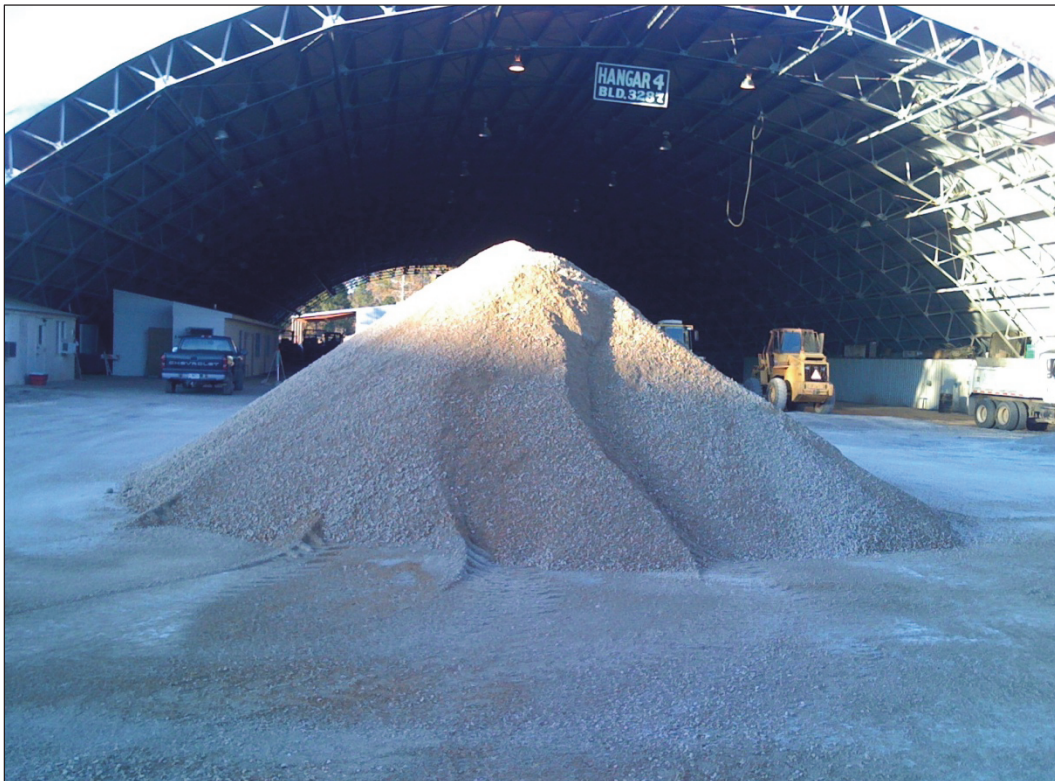
Figure 24. Blended subbase material stockpile.

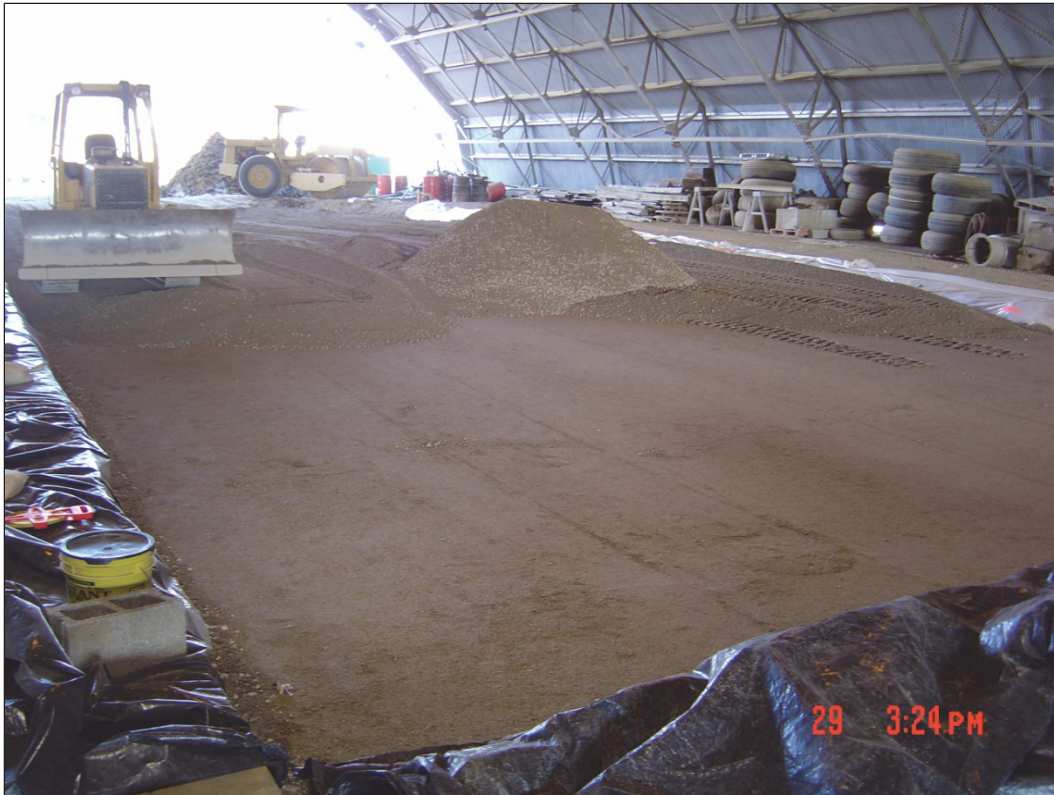
Figure 25. Subbase placement activities.

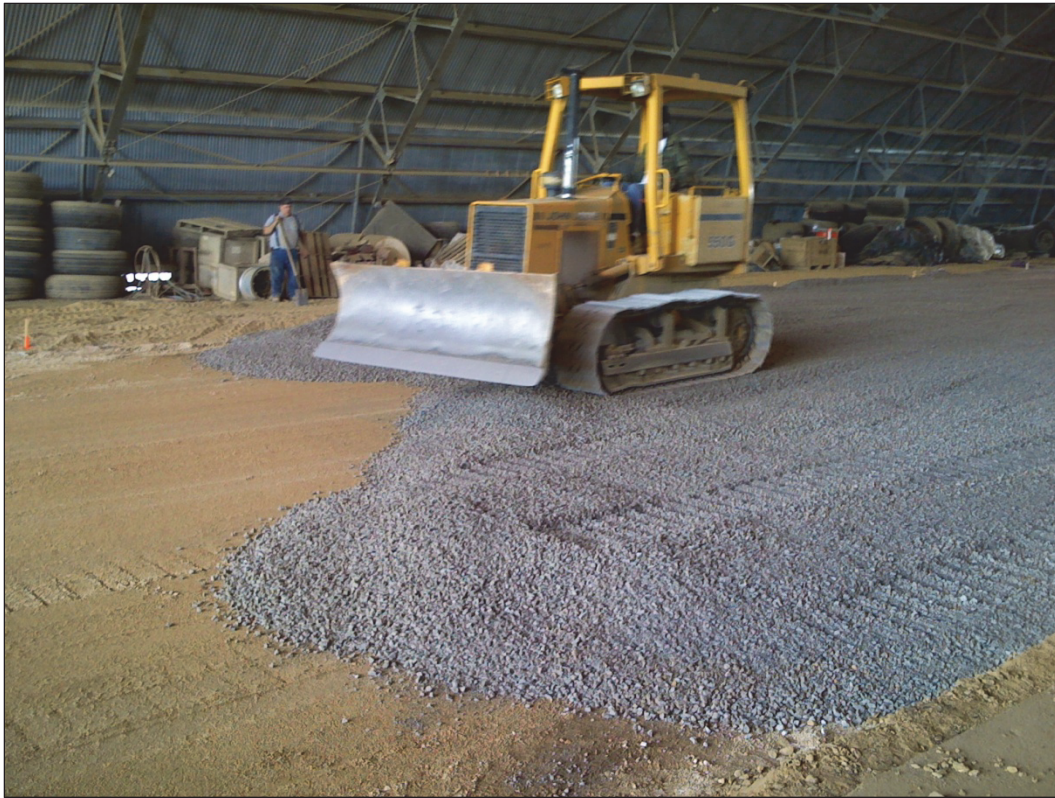
Figure 27. Base layer placement.

The base course was a 6-in.-thick layer of ASTM 568 crushed limestone. Figure 27 shows the placement process of base course material. The base lift was compacted by 16 passes of a self-propelled vibratory steel roller. Figure 28 shows dry density, wet density, and moisture content values as a function of the number of passes of the vibratory roller following the same procedure used for the subbase material. The base material achieved maximum density in about 10 passes of the vibratory roller. Moisture content remained constant at approximately 3% during placement. Table 7 contains the measured values of density (wet and dry) and moisture content in relation to the number of passes of the vibratory roller. CBR tests were executed after placement and final compaction of the granular material. Table 8 contains the CBR test results for each test item.

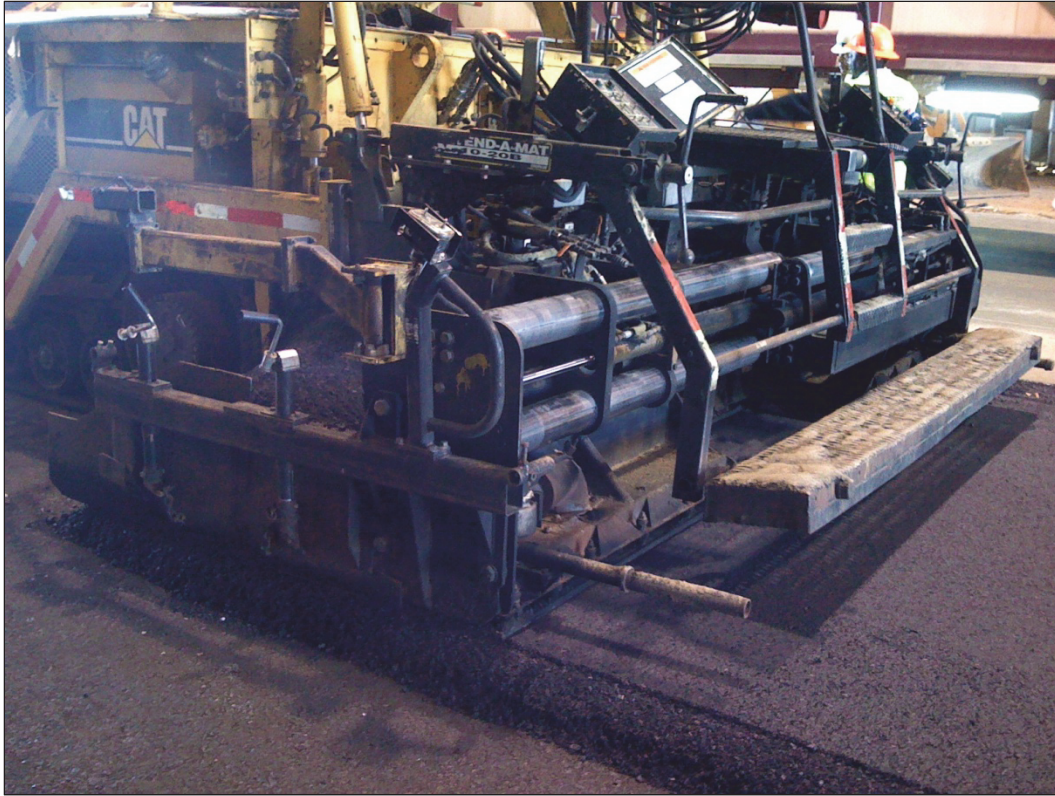
Figure 29. Paving operations, mat placement.

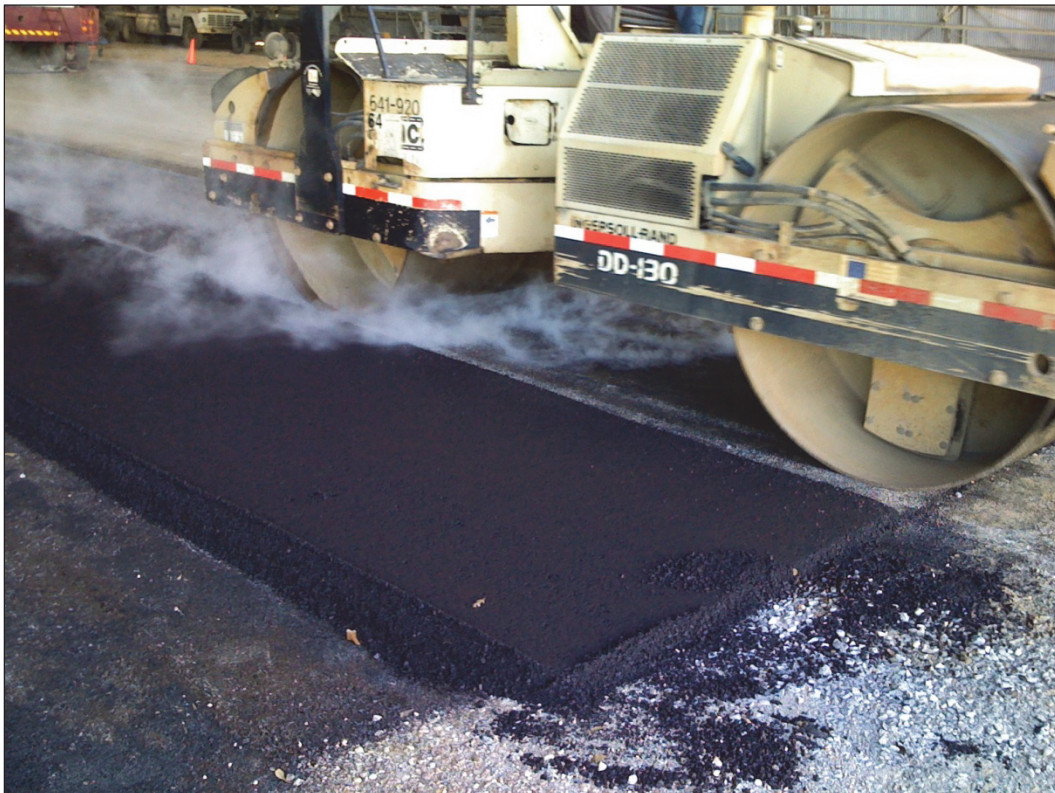
Figure 30. Paving operations, break-down rolling.

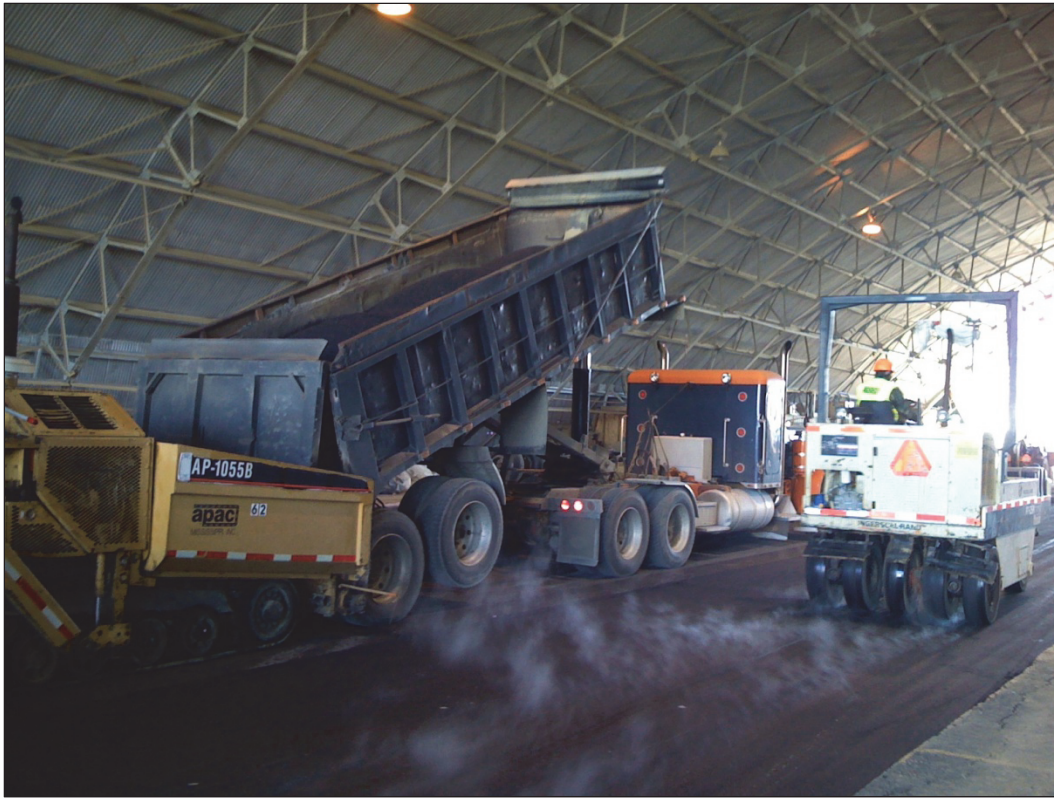
Figure 31. Paving operations, rubber-tire roller compaction.

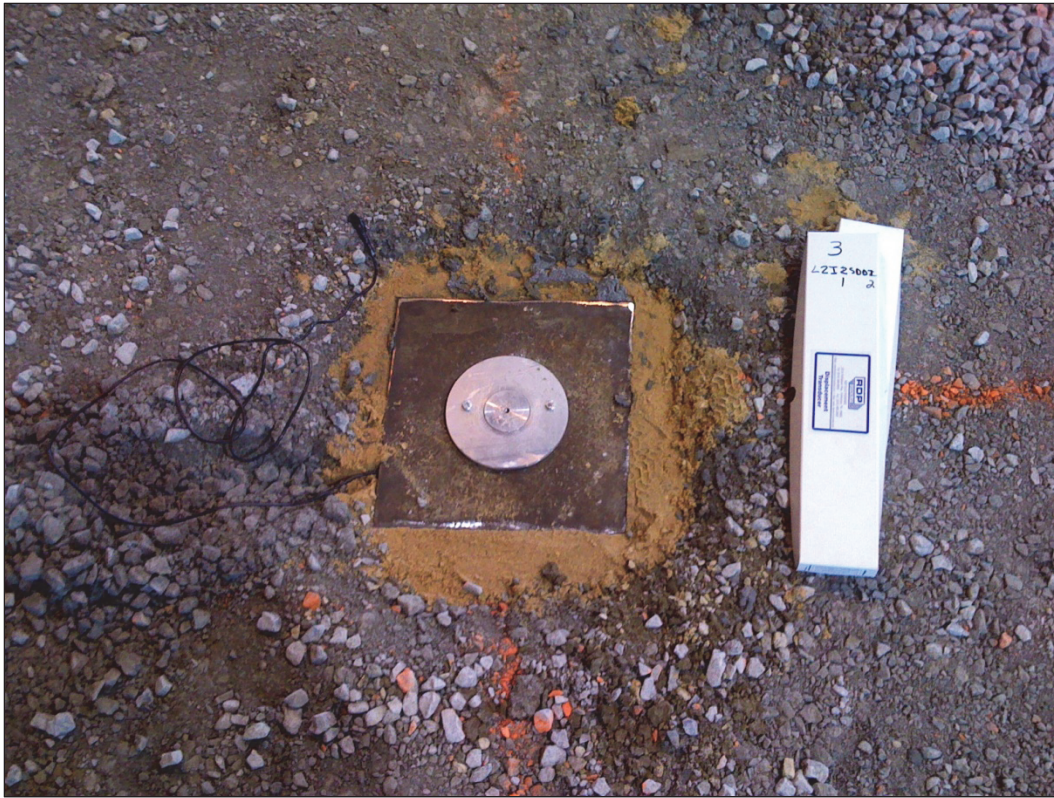
Figure 36. SDD after installation.

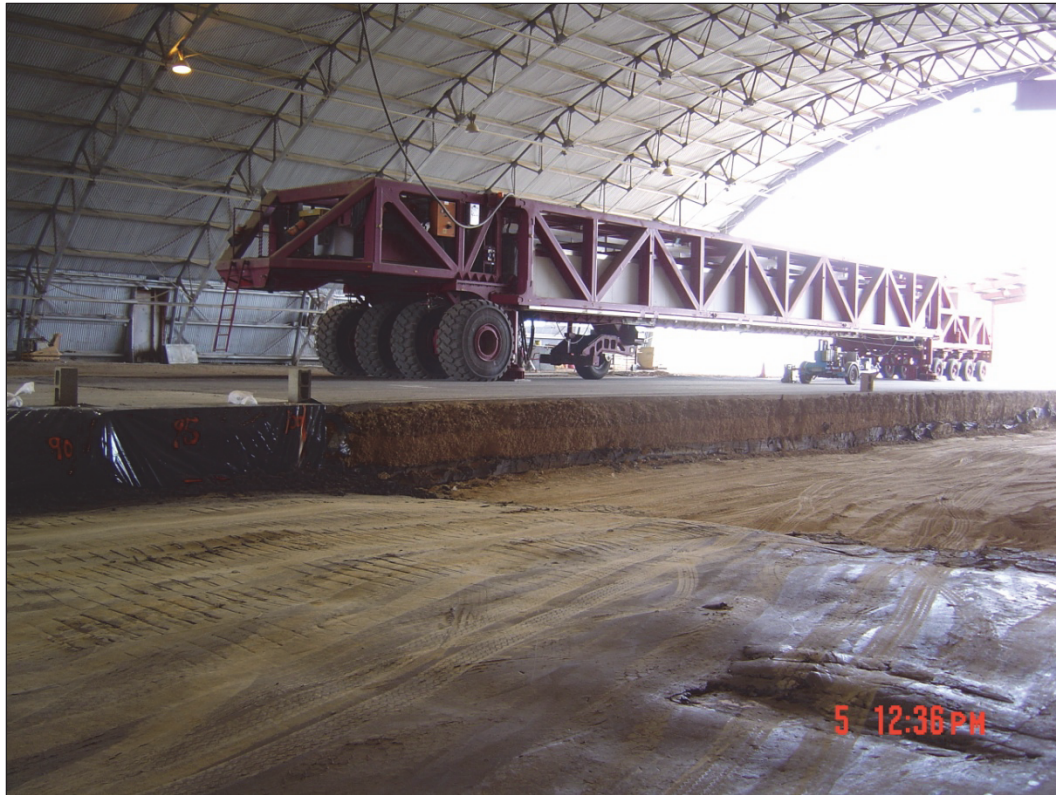
Figure 38. Heavy Vehicle Simulator (HVS-A) used for traffic testing.

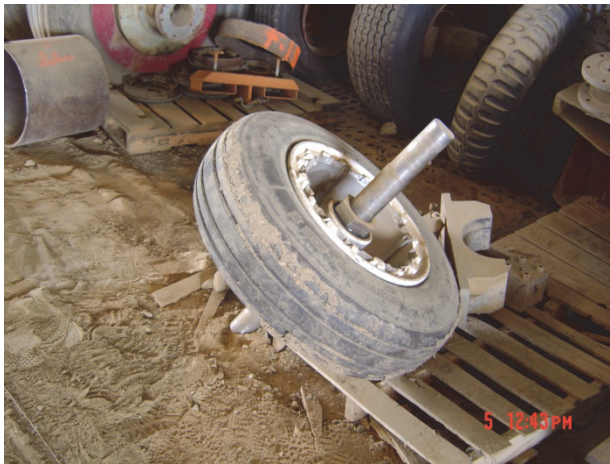
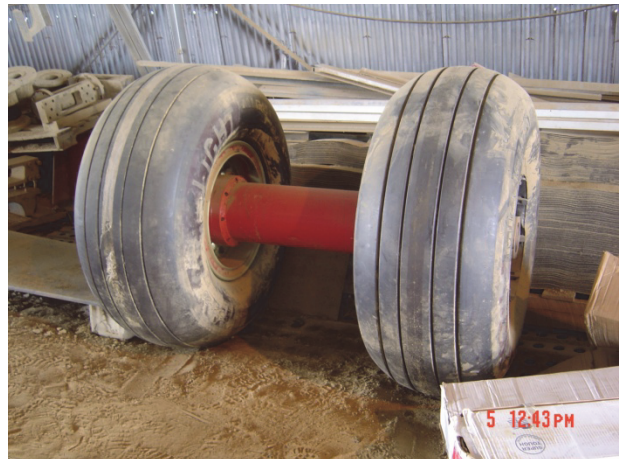
Figure 40. Single F-15E gear (left) and dual C-17 gear (right) tire assemblies.

items. The test section was divided into three traffic lanes to apply traffic with the F-15E single tire, the C-17 single tire, and the C-17 dual-tire gear. The nominal widths were 5 ft, 10 ft, and 5 ft for traffic lanes 1, 2, and 3, respectively, with 5 ft of buffer strip between each lane and a 5-ft clearance at each end of the test section. Figures 5 and 39 show the section layout with an indication of the traffic lanes. Figure 40 shows the single- and dual-tire assemblies used for the testing.

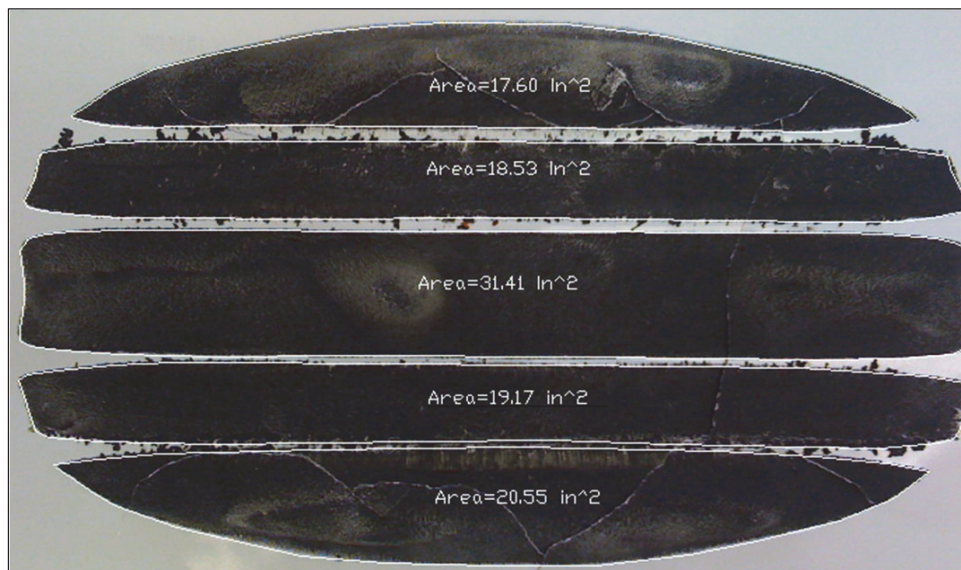
Figure 41. F-15 tire imprint.

Lane 3 was trafficked with the F-15 tire. The tire was loaded to 35,235 lb with an internal tire pressure of 325 psi. This loading and tire pressure yielded a computed contact area of 108 in². The measured contact area had a width of 8.8 in. and a length of 15 in. The computed area, based on the assumption of an elliptical shape, was 104 in². The contact area for this tire was slightly squarer than an ellipse; thus, the computed elliptical area would be slightly lower than the actual contact area (Figure 41). Nevertheless, it was concluded that the approach of using the tire load and tire pressure to compute an elliptic contact area was sufficiently accurate for design and evaluation.

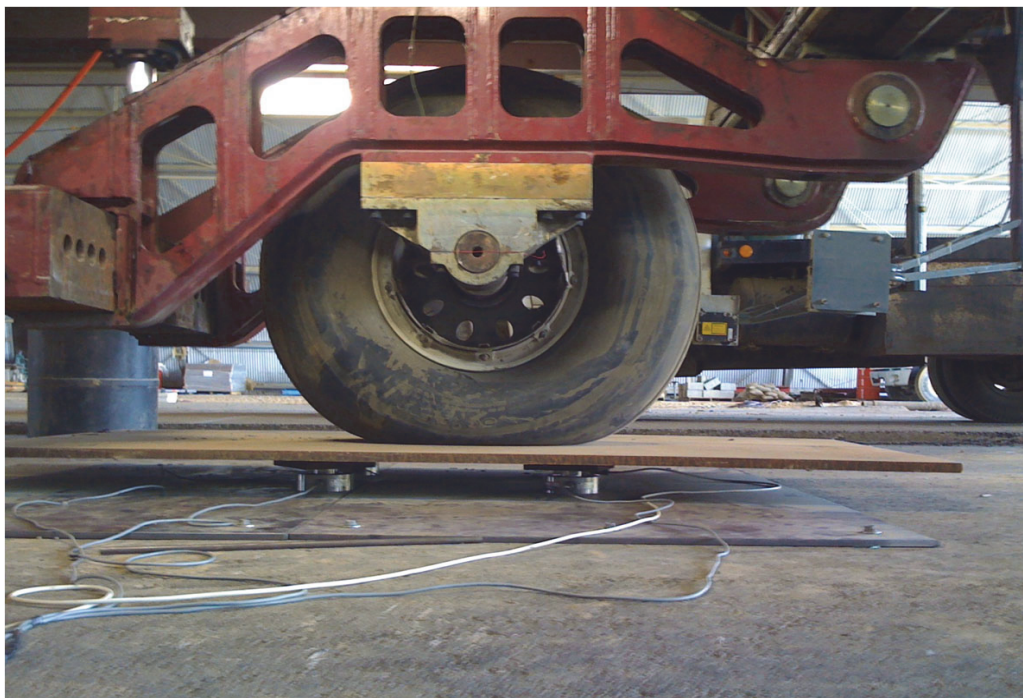
Figure 46. HVS-A calibration.

The HVS-A was calibrated prior to traffic to ensure the correct loading was applied (Figure 46). The HVS-A applies the load through a hydraulic ram and lever arm system.

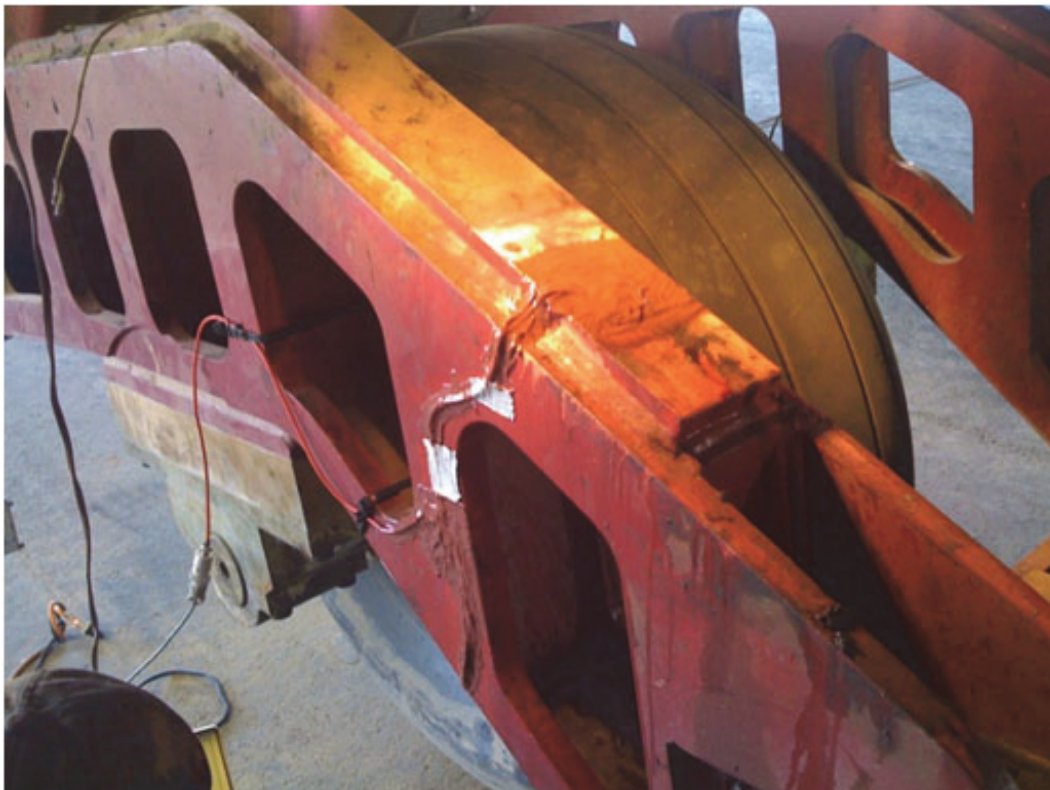
Figure 53. Carriage strain gauge arrangement.
